Manhole Inspection Summary

Manhole # S35CC1010MH

Insp Date: **12/7/06 10:33 AM**

Location Address: **218 CHANCEY RD**

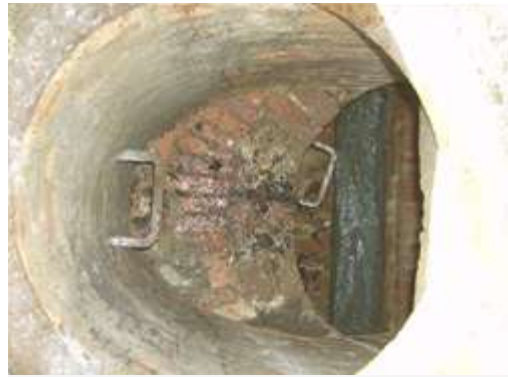
Top View

Bench debris.

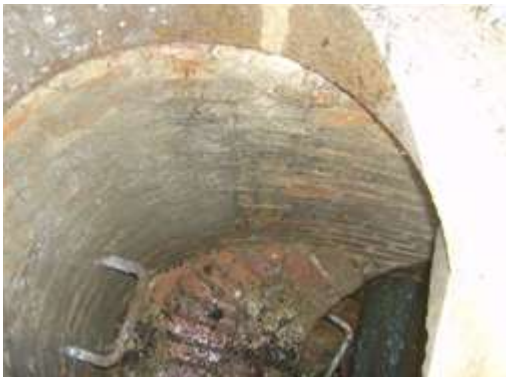
Defect

Condition: ☐ Sound ☐ Cracked ☐ Root Intrusion ☐ Loose Brick ☒ **Deteriorated**

Infiltration: ☐ None ☒ **Joint** ☐ Cracks ☐ Mortar ☐ Roots ☒ **Wall**

Adjustment deterioration and infiltration.

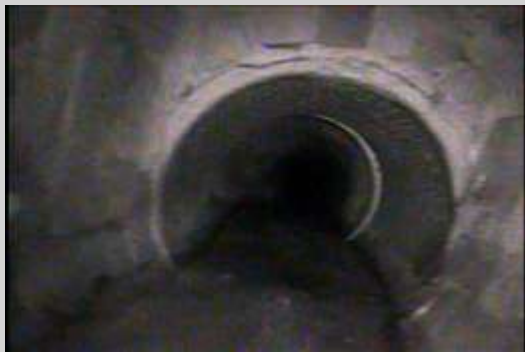
12 in. Circular Gravity Sewer Pipe Out @ 12 O'Clock

Infiltration: **Evidence** Pipe Seal Cond: **Cracked**
